SURFACE TREATMENT FOR ALUMINUM BONDING.(U)

SURFACE TREATMENT FOR ALUMINUM BONDING

FINAL REPORT FOR THE PERIOD
July 28, 1978 through July 15, 1979

GENERAL ORDER NO. 5180
CONTRACT NO. DAAK10-78-C-0274

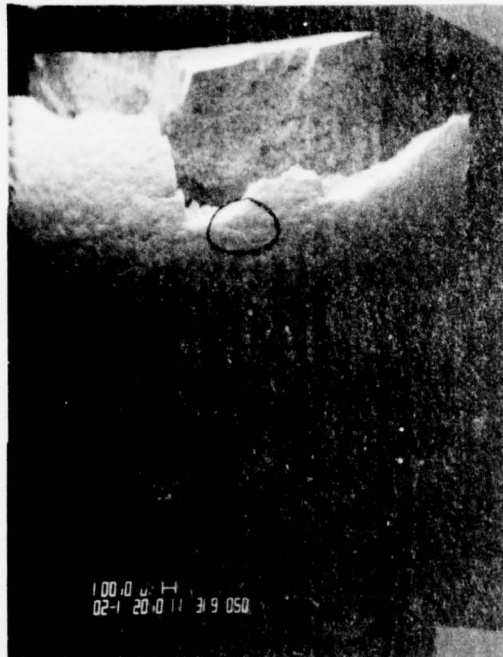
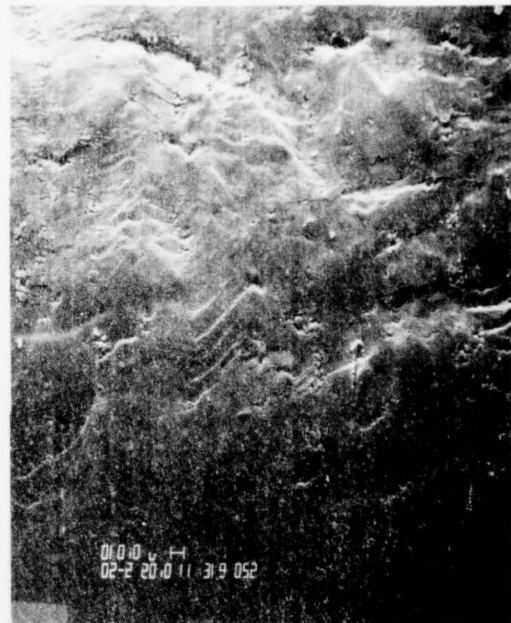
Fig. 2 SEM micrographs of Al 2024-T3 after STAB(1).

Figure 1 shows SEM micrographs of degreased Al 2024-T3 prior to STAB(1). The top pictures (a) are for unbent specimens, the bottom pictures (b) are for specimens that have been bent to fracture the surface. Figure 2 shows SEM micrographs of bent Al 2024-T3 after STAB(1). A very porous hydroxide is formed that appears to be ideal for mechanical interlocking with adhesive. The porous film is approximately 2000Å thick. Although it is not obvious in Fig. 2, other micrographs reveal a second layer under the top layer.

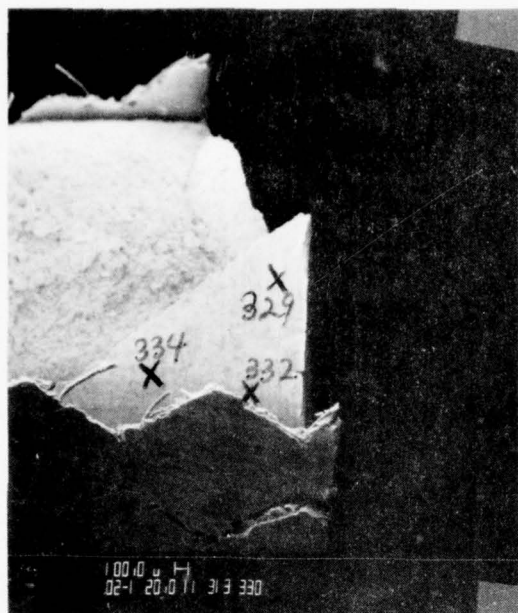
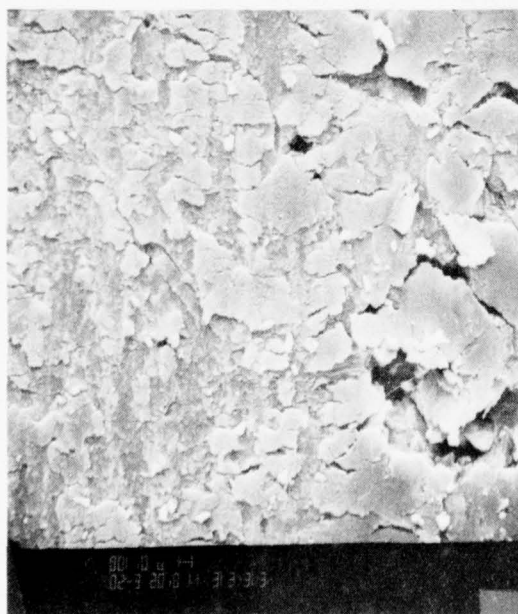
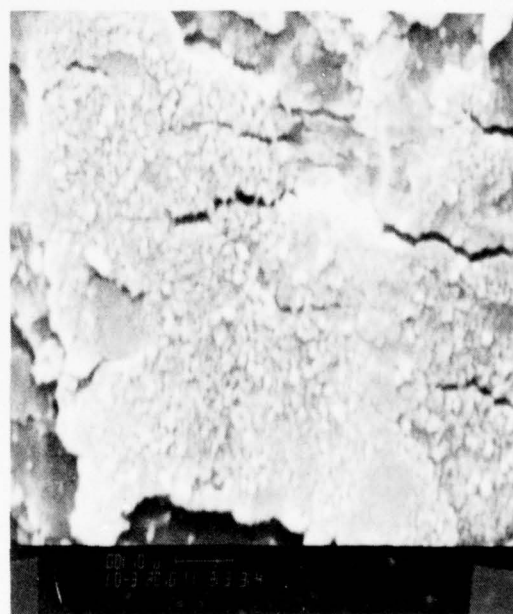
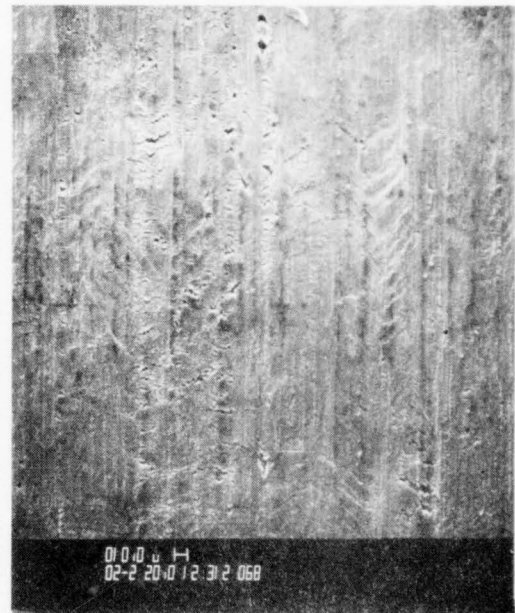
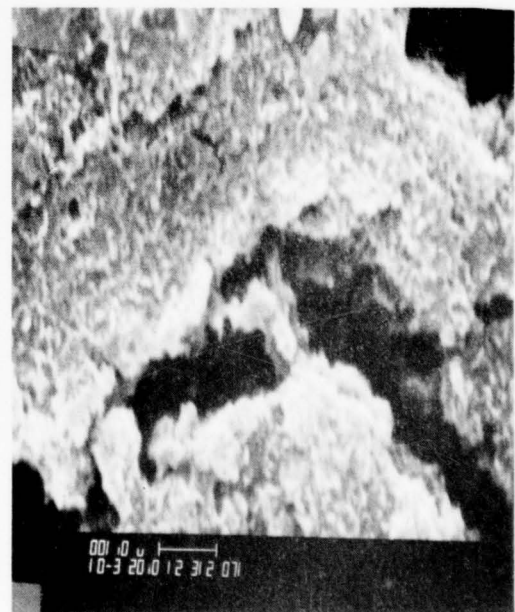
Fig. 16 SEM pictures of the debond region of a good wedge test joint (STAB(1)).

Figures 16a-d are SEM pictures of the metal debond region of a wedge test that was good (~1.78 cm (0.3 in)/24 hr) after STAB(1). Figure 16a is X10, b is X200, c is X2000 and d is X10,000. The hydroxide film is seen to be layered and is fractured due to bending of the cut out piece. The X10,000 picture (d) reveals the cellular porous structure of the hydroxide, and when compared to Fig. 2, appears to have failed in the primer-hydroxide interface. Figures 16e-h show the metal surface that did not debond during the wedge test but fractured during metal bending. Again the failure is at the hydroxide-primer interface, the layered film is observed but in this case it is obvious that failure had occurred in the primer, leaving primer embedded within the hydroxide.

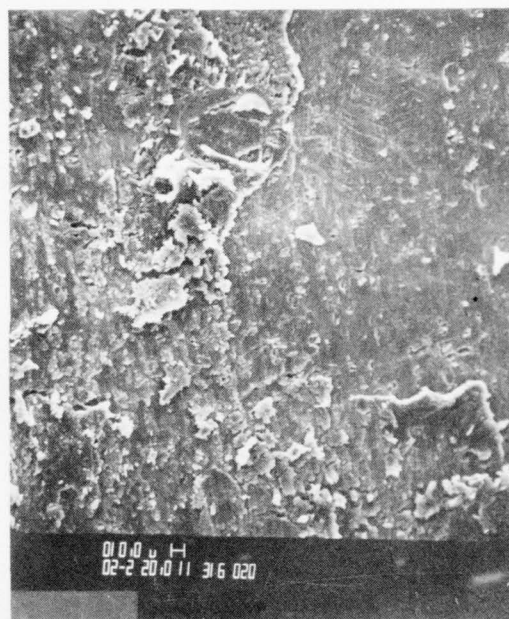
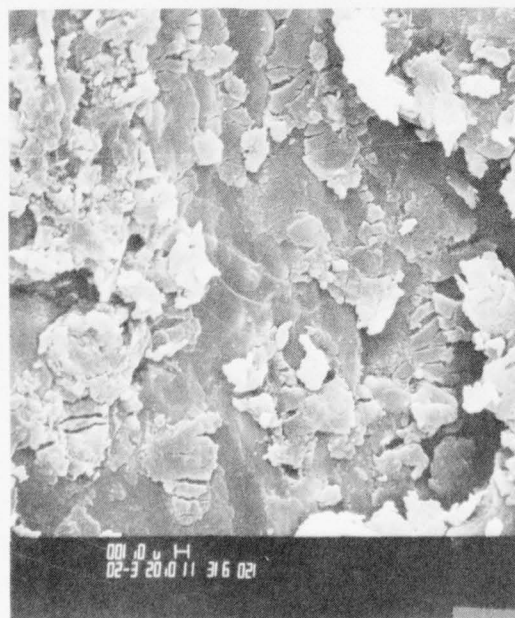
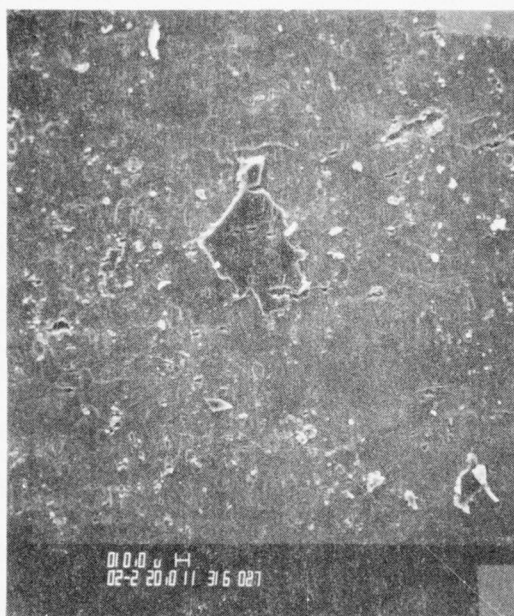
Fig. 17 continued

Figure 17a-g is of the debond region of a joint after STAB(1) which was medium with regard to the wedge test (~0.7 in/24 hr). Figure 17a is a low magnification showing the adhesive peeled away from the metal during metal bending. The holes in the adhesive layer were caused by gas bubbles that are found in nearly every hexagonal cell outlined by the nylon scrim. If the bubbles are excessively large, the thin adhesive (or primer) layer tears away from the adhesive layer and remains on the adherend and a hole is left in the adhesive film. Figures 17b, c and d reveal the mating adhesive surface, in the region marked by an X in Fig. 17a. The adhesive appears rather smooth and untorn but Fig. 17d indicates a thin (2000A-3000A) layer has been transferred from the metal. The picture numbers identify the regions in Fig. 17e where they were taken. For example, Figs. 17f, g and h show increasing magnifica-

tion of region 20 at the left of Fig. 17e. The main feature is the layers of hydroxide along with large particles of adhesive. Failure appears to be primarily in the hydroxide lamellae. Figure 17i reveals a small piece of primer (circled in Fig. 17e). A larger magnification of part of the primer particle is seen in Fig. 17j, it is very smooth on top and indicates delamination at the primer-adhesive interface. Figures 17k and l are larger magnifications of the region around the primer, i.e., hydroxide that has appeared to have failed between lamellae. Note that the surface structure does not appear as in Figs. 2c and d.

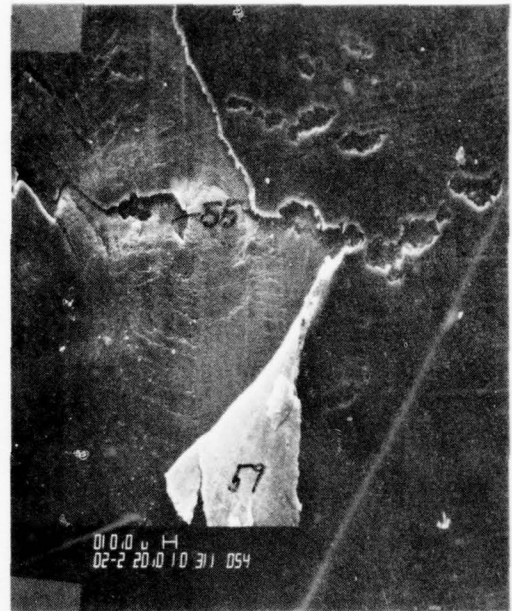
Fig. 19 SEM pictures for debond region in a bad wedge test joint (STAB(1)).

Figure 19 is for a wedge test that was bad (~3.0 cm (1.2 in)/24 hr). In Fig. 19a large pieces of primer remain on the surface in the debond region. They seem too big to be formed by bubbles but are probably due to poor contact between the primer and adhesive. Figures 19c and d are larger magnifications of the region 55 in Fig. 19b. The peeled back piece of primer (region 59) in Fig. 19b and the enlargement of this region in Fig. 19h reveal failure between lamellae in the hydroxide film, a layer of hydroxide has been transferred to the primer. Figure 19e shows a region of the debonded adhesive. Although the roll pattern from the metal is on the adhesive, Fig. 19f (a larger magnification of 19c) shows that failure occurred cohesively in this region. Figure 19g is a larger magnification of the primer surface.
